Structural Analysis of DEW Line Station DYE-2, Greenland

1983-1988

Michael R. Walsh and Herbert T. Ueda

CRREL Report 98-3

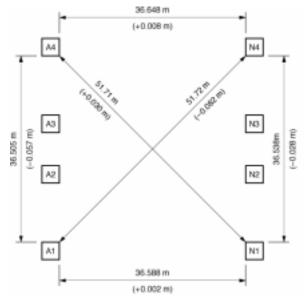
Figure 10. Horizontal movement of columns at snow surface.

Finally, as the footings settle and the ice cap drifts (App. A), the columns move differentially with respect to each other (Fig. 10). This differential movement, in addition to the column out-of-plumbness mentioned above, sets up horizontal distortions in the column–truss system that can result in high loads at restraining points at the collars and in the building. High bending moments at the column bases are a result of these large horizontal loads. The horizontal distortion of the truss system may also be the reason why pinching and spreading loads sometimes appeared during sway bolt measurements (described in

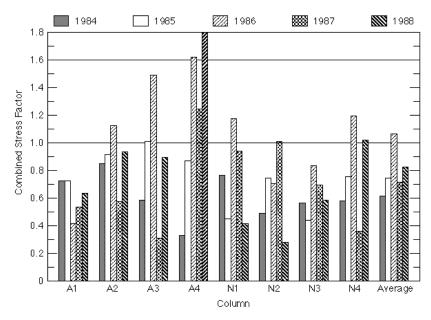
Figure 12. Summary of base level stress concentration factors: 1984-1988.

low, with an average base level combined stress factor (BLCSF) of about 0.61. BLCSFs are calculated loads on the column bases caused by stresses measured in the four collars of each column. There is no obvious pattern to the stress levels. None of the column BLCSFs exceed 1.00. In 1985, the stresses have become redistributed. The average BLCSF has increased to 0.71, with one column exceeding 1.00. Again, no pattern is obvious, although the A row is more heavily loaded than the N row.

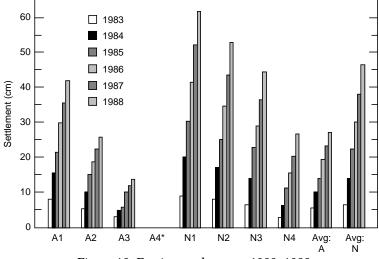
Figure 13. Footing settlements: 1982–1988.

at differing rates. Figure 13 shows the settlements of the A and N row of columns, as well as the averages of each respective row. Footing A4 was used as the datum point as this was the slowest settling footing and was used as the "baseline" footing previous to the move in 1982. Therefore no settlements are given for it.

From these figures, several observations can be made. The most obvious is that the N row is settling faster than the A row. The average rate of settlement of the N row with respect to A4 is 0.08 m/year. The settlement of columns A1 through A3 with respect to A4 is only 0.05 m/year. Footing settlement data can be found in Walsh (1992).

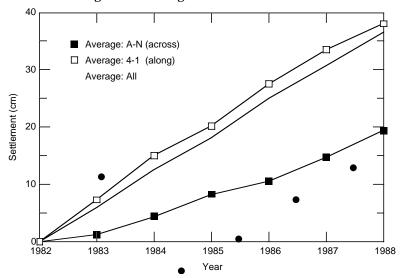
Figure 14. Footing settlement trends.

A3, N3, and N4, we can see how this happens. As A3, N3 and N4 settle respective to A4, the building and truss also settle with respect to A4 at those locations. From Figure 14, the direction and magnitude of the footing tilts averages approximately 300° and 0.014 radians, respectively. The highest loads in the building and truss levels should then be at A4 with intermediate loads at A3 and N4 and the lowest loads at N3. The horizontal loads should be greatest where the settlement is least. Data taken during the 1988 field work confirm both conditions. This also applies to the forward truss.

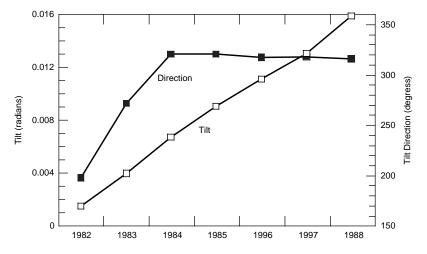
Figure 17. Footing tilt trends.

ern corners (A4 and A2), with the rear truss system (the A4 system) the more heavily loaded. This ultimately affects the base level stress factors.

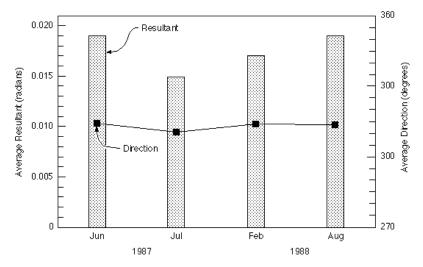
Figure 18. Column tilt trends.

Analysis of the data collected for all aspects of the system indicate an inexorable tilt of the structure along with related structural stress increases. The direction of tilt is towards the "warm" southwest corner of the building. The highest

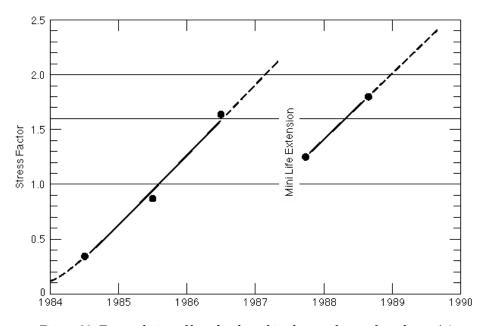
Figure 20. Extrapolation of base level combined stress factors for column A4.

not done. From the data, one can see a rise in the general state of stress in the structure, especially in column A4, which has a combined stress factor well in excess of 1.60. Extrapolation of this and previous years' data indicated a combined stress factor of more than 2.00 by year's end (Fig. 20).

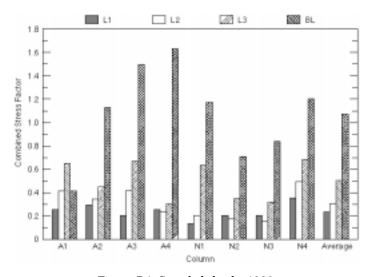
Figure B4. Swaybolt loads: 1986.

Figure B4 contains the third complete set of combined stress factors since the move in 1982. It is interesting to compare stress factors for 1984 through 1986 for trends. High stress concentration factors in general, and especially at column A4 (>1.60), led to a recommendation that work be contracted for the next summer to alleviate some of the high stresses. Column tilts were also a factor in this decision.

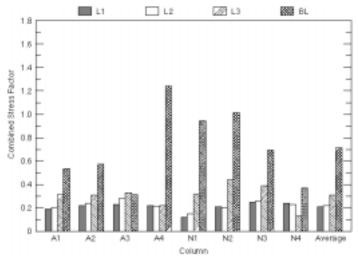
Figure B5. Swaybolt loads: 1987.

Figure B5 contains the fourth complete set of combined stress factors since the move in 1982 and the first since the mini-life-extension of 1987. Comparing stress factors for 1984 through 1987 points up several trends that are more obvious when examining Figure 12. Although the mini-life-extension served to lower most stress and redistribute stresses among the columns in general, trends dictated a repeat of the work performed in 1987 to assure the structural integrity of the building. Another mini-life-extension was therefore recommended for 1988.

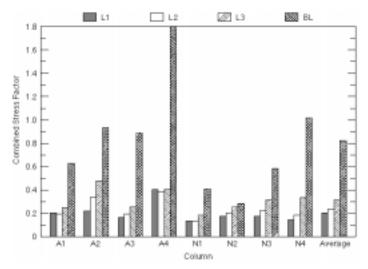
Figure B6. Swaybolt loads: 1988.

Figure B6 contains the final complete set of combined stress factors calculated for DYE-2 and the second since the mini-life-extension of 1987. Comparing stress factors for 1984 through 1988 points up several trends which are more obvious when examining Figure 12. Although the mini-life-extension was recommended for the summer of 1988, funding difficulties were encountered and the work was
